# SUCCESSFULLY LOWERING THE RISKS AND COSTS ASSOCIATED WITH THE LEGACY OF THE ABANDONED BRUKUNGA PYRITE MINE, SOUTH AUSTRALIA<sup>1</sup>.

Ray Cox , Peter Grindley, Jeff Taylor and Sophie Pape<sup>2</sup>.

**Abstract.** Pyrite (FeS<sub>2</sub>) and pyrrhotite (FeS) were mined by open pit methods at Brukunga, South Australia, between 1955 and 1972. Eight million tonnes of waste rock (2 wt.% S) and 3.5 Mt of tailings (1.7 wt.% S) were produced. Oxidation of this material, and remaining in-situ rock mass, has resulted in acid drainage (pH<3) with elevated sulphate and dissolved metals. Prior to June 2003 this acid drainage entered Dawesley Creek making the water unsuitable for livestock and irrigation use for up to 20 km downstream. The site is now under the care of the State Government.

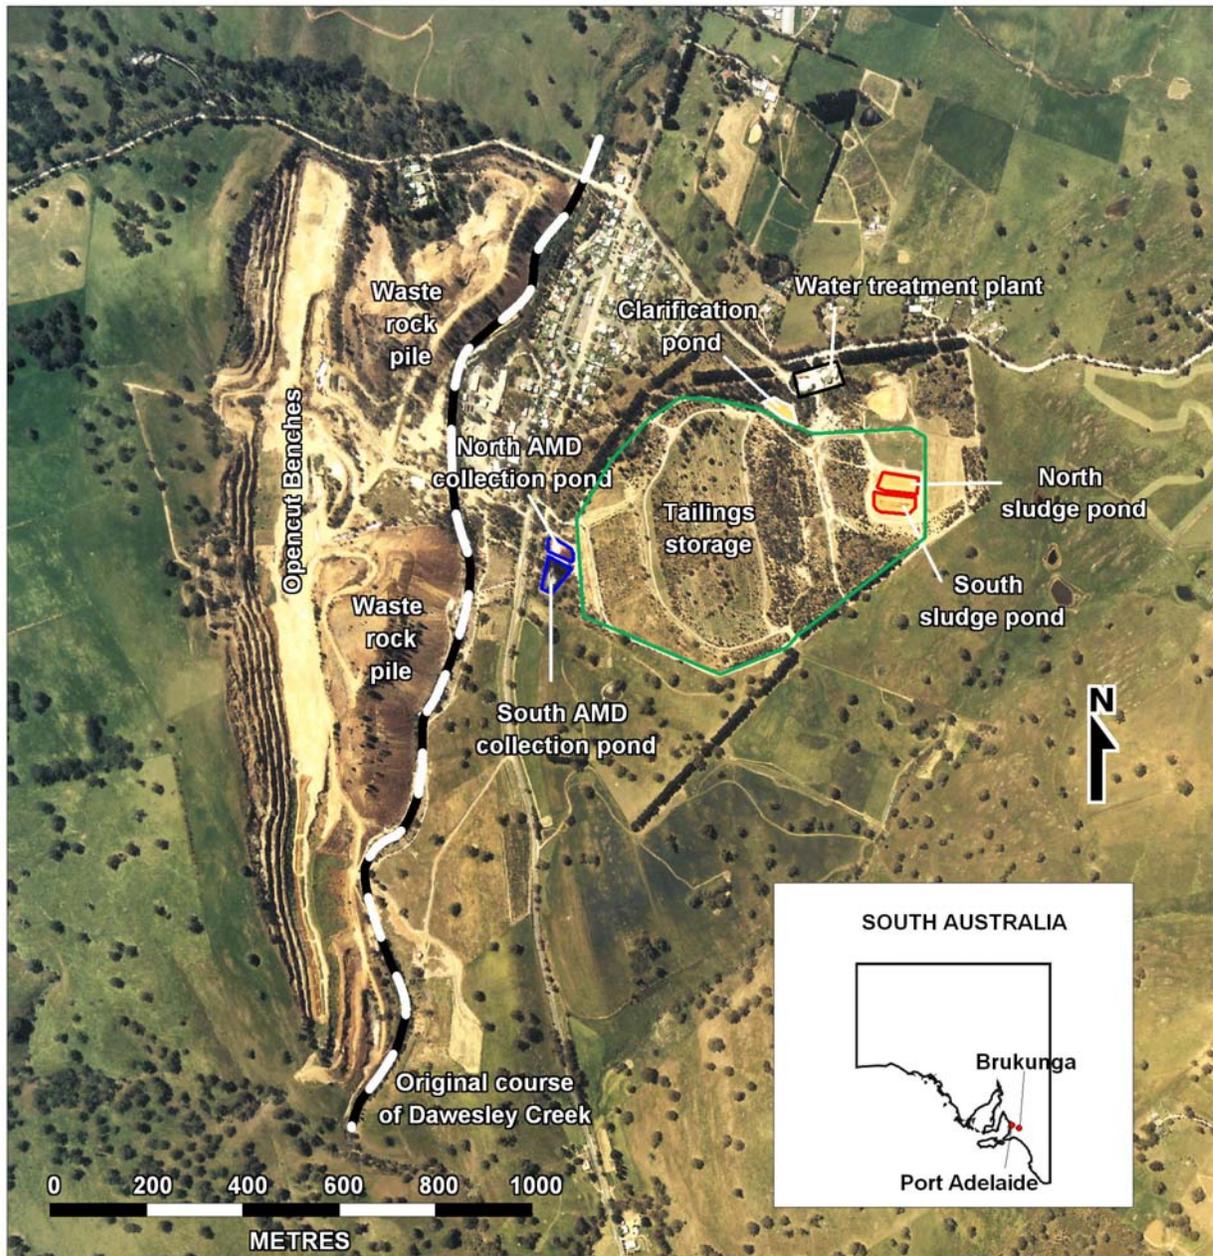
Figure 1. Location of the Brukunga Pyrite Mine and key site features.

The Brukunga pyrite mine is located 4 km north of Nairne and 40 km east of Adelaide in the Mount Lofty Ranges of South Australia (Figure 1). Iron sulphide (pyrite and pyrrhotite) was mined at the site between 1955 and 1972. During mining operations, two large waste rock piles were generated from approximately 8 million tonnes of sulphidic overburden material (2 wt.% S), and a valley-fill tailings facility adjacent to the mine was filled with 3.5 million tonnes of sulphidic sand-tailings (1.7 wt.% S) (PIRSA, 2003a).

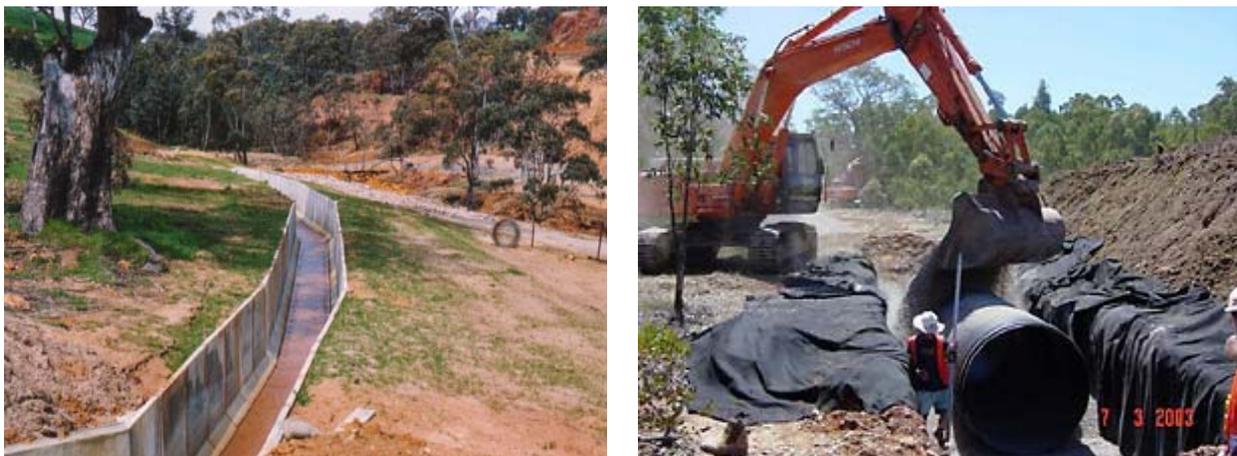
Figure 2. Dawesley Creek diversion drain. Laying pipe for the underground segments of the drain (right) and open channels (left).

In June 2003, Stage 1 of the program, construction of the Dawesley Creek diversion, was successfully completed. The diversion isolates Dawesley Creek from the pollution generated at the mine site. The 1.7 km diversion includes 780 metres of 1.5 metre diameter reinforced concrete pipes, 175 metres of High-Density Polyethylene (HDPE) plastic pipe and 750 metres of drilled and blasted open channel (Figure 2). The original section of creek, adjacent to the waste rock piles, now provides a sink for the collection of acid drainage that previously flowed directly into the creek. Construction of the drain resulted in an immediate improvement in water quality in Dawesley Creek downstream of the mine for the first time in 50 years.

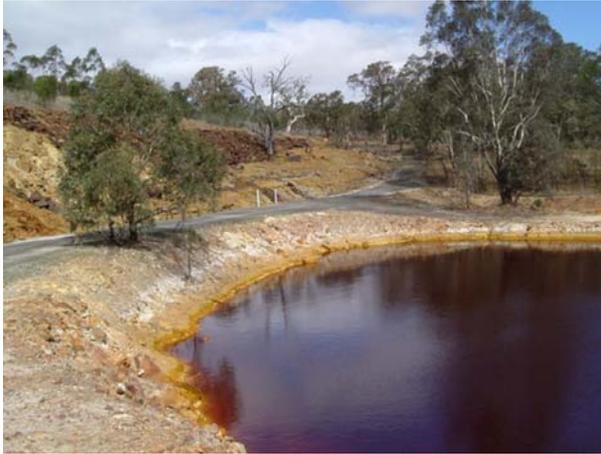
Figure 3. Acid drainage from the site is pumped to the North AMD holding pond (shown) prior to treatment.

The existing treatment plant was designed to treat 20 kL of acid drainage per hour, but has dealt with flow rates between 10 and 35 kL per hour. Treatment requirements are greatly affected by seasonal and local rainfall events. During summer the plant is often shut down, but during the wet winter months (June through September) the plant operates 24 hours/day and 7 days/week to maintain water levels in the North and South AMD holding ponds.

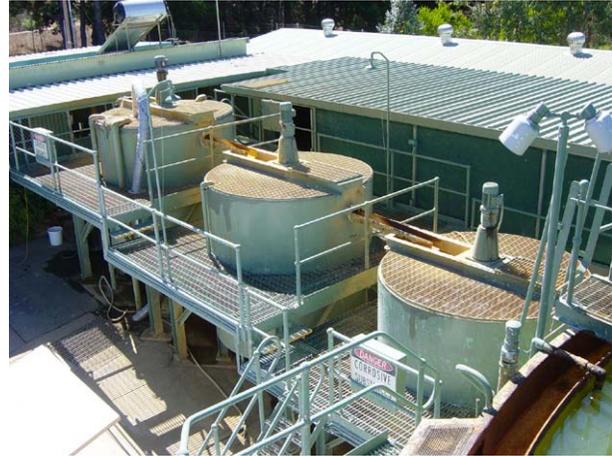
Figure 4. Reactors 1, 2 and 3 as viewed from the thickener tank (existing plant).

Untreated water typically has low pH (2.5-2.9), high conductivity (6,970-11,800  $\mu\text{S}/\text{cm}$ ), high concentrations of sulphate (8,240-14,000 mg/L) and elevated Al, Cd, Cr, Cu, Fe, Pb, Mn, Ni and Zn. This water is pumped from the North AMD holding pond (Figure 3) into the first of three 12 kL reactor tanks (Reactor 1) in the treatment plant (Figure 4).

Water from Reactor 1 flows by gravity to Reactors 2 and (subsequently) 3. The use of three reactor vessels provides the retention time required for the completion of the treatment reactions. Water exiting Reactor 3 then flows into a below ground sump. When the sump is full, water is pumped up to a 390 kL thickener / clarifier tank. Flocculant is dispensed into the stream of water from the below ground sump before it enters the thickener / clarifier tank (Figure 6). Clear supernatant water from the thickener / clarifier tank overflows to a clarification pond before being released into Dawesley Creek, downstream of the mine site.

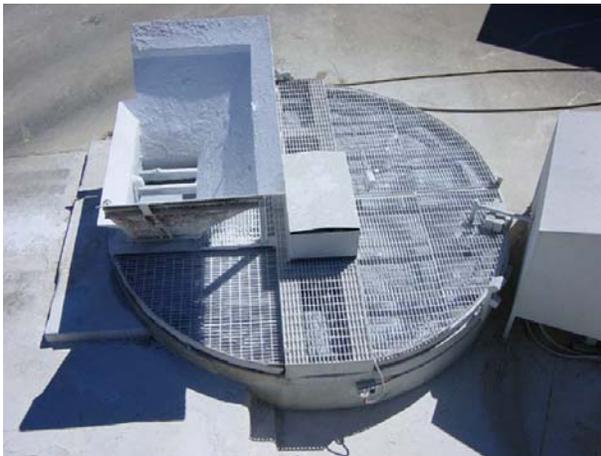
Figure 5. Below ground hydrated lime storage, mixing and dosing system.

Carbide lime slurry is mixed in a 50 kL below ground tank (Figure 5), and dispensed to Reactor 1 as required to achieve a pH of approximately 9.5 in water exiting the plant. The carbide lime is a form of hydrated lime that is a by-product of the acetylene manufacturing process. The reagent therefore contains minor impurities (eg.  $\text{CaC}_2$ ) that are not present in conventional hydrated lime. Carbide lime slurry is delivered to the site by road tanker 3 days a week. Excess slurry is stored in an evaporation pond to the west of the plant. Partially-dried carbide lime from the evaporation pond is transferred to one of two above-ground temporary storage areas. When required, the partially-dried carbide lime is added (with water) to the 50 kL

below ground lime slurry tank. Annual consumption of reagent is variable but averages approximately 600 dry tonnes per annum.

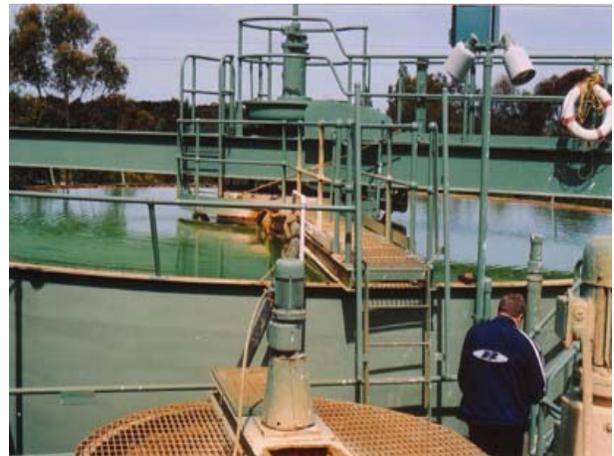
Figure 6. Thickener / clarifier tank.

Settled sludge in the base of the thickener / clarifier tank is either recycled into Reactor 2 or pumped to one of two sludge ponds located on the tailings facility. The low-density sludge exiting the plant prior to its upgrade was between 3 and 5 wt% solids.

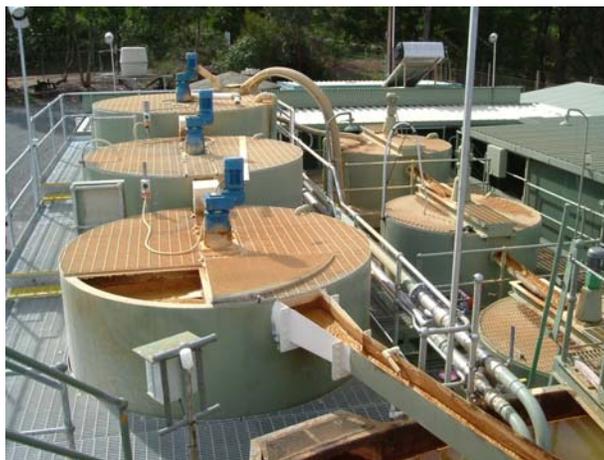
Figure 7. New treatment plant showing second parallel series of reaction vessels (upper left) with existing upgraded plant (lower right).

In May 2005, a second parallel series of 3 larger reaction vessels was installed to effectively double the treatment capacity of the plant (Figure 7). This new plant also operates in HDS mode and has a design capacity of 25 kL/hour. The installation of the new plant and upgrade to the existing plant was completed at a cost of \$750,000 (AUD). Improvements in sludge density and settling characteristics enabled the existing thickener to accommodate the sludge output of both plants.

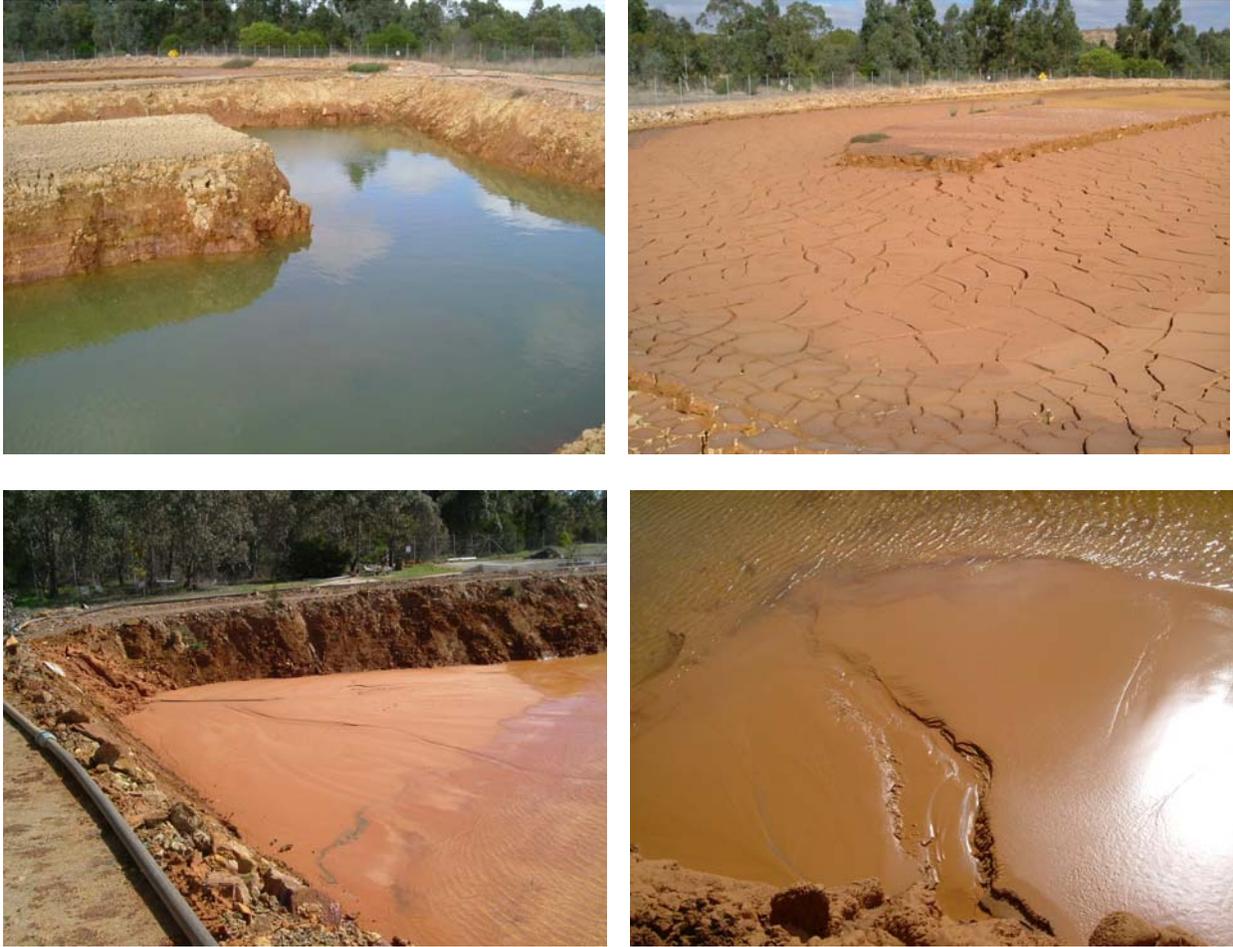
Figure 8. Sludge pond. Low-density sludge prior to plant upgrade partly fills one of the two sludge ponds (upper left). Sludge pond full of partially air dried sludge prior to desludging (upper right). High-density sludge entering sludge pond after plant upgrade (lower left and right).

Conversion of the existing plant to HDS mode has led to a reduction in the volume of sludge produced and costs savings in the order of \$30,000 (AUD) per annum related to the settling pond desludging requirements. Sludge from the thickener / clarifier is now being produced at up to 42 wt.% solids with the HDS process in comparison to 3-5 wt% prior to the upgrade of the existing plant. This equates to a reduction of greater than 50% in the total volume of sludge produced.

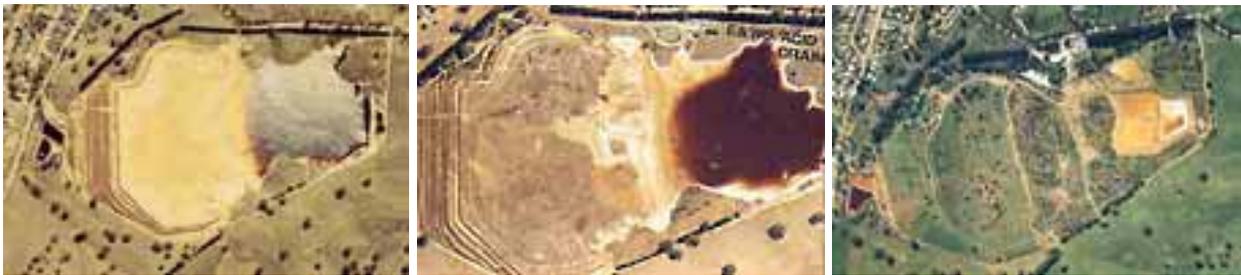
Figure 9. Aerial view of the progressive rehabilitation of the tailings storage facility. Far left: 1973, 12 months after closure of the site. Middle: 1985, remaining acid water on tailings facility after initiation of treatment in 1980. Right: 1997, revegetated surface of the tailings facility.

Rehabilitation and revegetation of the tailings facility commenced in 1987 with trials using a thin (30 to 50 cm) soil and rubble layer spread over the tailings. Each year several thousand native tube-stock have been planted. The vegetation has reduced surface erosion, improved the visual appearance, and provided habitat for native fauna. In addition to this the capping and revegetation of the tailings facility has acted as a store and release cover, forming an evapo-transpiration layer that serves to reduce the deep percolation of rain into the tailing sand. Moisture is temporarily held in the root zone of the plants and from there it evaporates or is drawn up into the vegetation. This has greatly reduced deep percolation and hence the quantity of acid seeping from the toe of the tailings embankment. Measurements of depth to ground water in boreholes recorded each year indicate that the tailings facility is continuing to dry internally. This is also confirmed by decreasing quantities of seepage measured at a v-notch weir below the tailings embankment.

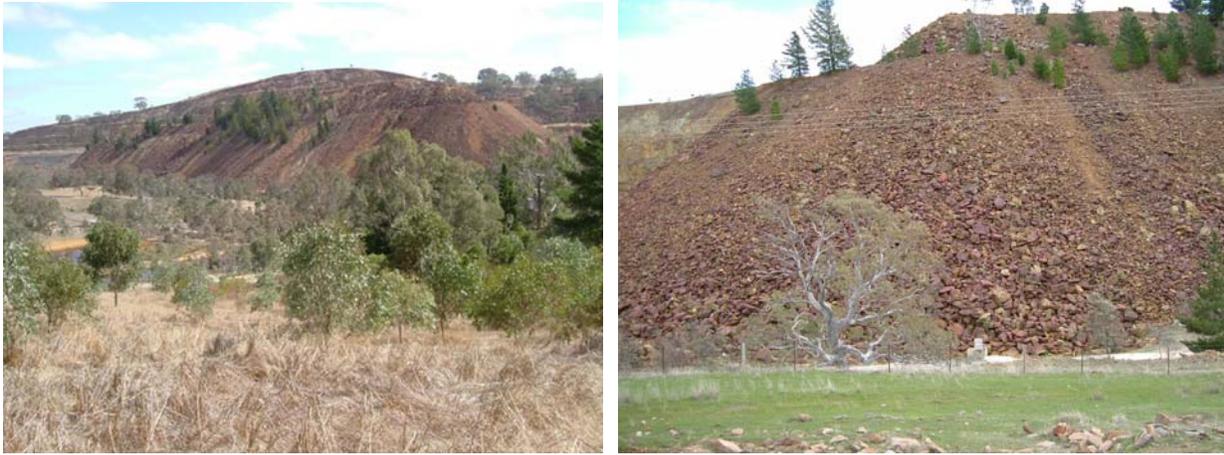
Figure 9. Waste rock piles at the Brukunga site, to be rehabilitated during Phase 3 of the remediation program.

The third stage in the rehabilitation works at the Brukunga site involves the reduction of acid generation and seepage on site. The key to this will be the rehabilitation of the waste rock piles on site. Currently waste rock piles are located along the base of the open cut bench and have not been capped. This allows uncontrolled infiltration of water into the piles, and results in seepage of acidic drainage generated within the piles (Figure 9).

A number of options are being considered for rehabilitation of the waste rock piles. These range from capping of the existing piles to completely relocating the waste rock, either on or off site. A proposal is currently being considered to relocate the 8 Mt of waste rock back to the open cut and blend it with imported limestone marl. At present, cost estimates place this option at \$3M/year (AUD) over 7 years. On completion of the waste rock relocation and remediation, it is envisaged that acid seepage from the mine site will significantly diminish, resulting in greatly reduced ongoing treatment and maintenance costs.
